STM32F072x8/xB device errata

This document applies to the part numbers of STM32F072x8/xB devices and the device variants as stated in this page.

It gives a summary and a description of the device errata, with respect to the device datasheet and reference manual RM0091.

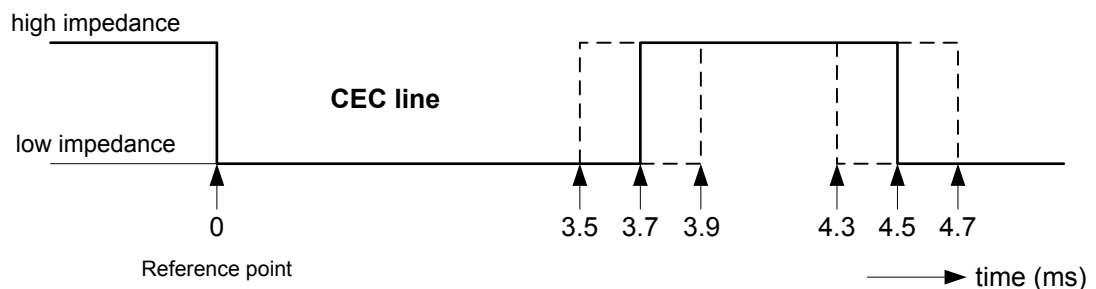
Figure 2. HDMI-CEC start bit format with tolerances

The start bit timing standard tolerances are shown in the following figure. The start bit is initiated by the device by driving the CEC line low (reference point). After 3.7 ms, the device releases the CEC line and starts checking its level. The following conditions must be met for the start bit to be valid:

If one of these conditions is not met, the transmission is aborted and never automatically retried. No error flag is set and the TXSOM (Tx start of message) bit is not cleared.

Workaround

The only way to detect this error is for the application software to start a timeout when setting the TXSOM bit, restart it upon ARBLST or any RX event (as the transmission can be delayed by interleaved reception), and stop it upon TXBR (proof that the start bit was transmitted successfully) or TXEND event, or upon any TX error (which clears TXSOM). If the timeout expires (because none of those events occurred), the application software must restart the HDMI-CEC peripheral and retransmit the message.
