# PEX 8509

PCI Express Switch

**Silicon Revisions and Errata List**

**Version 1.1**

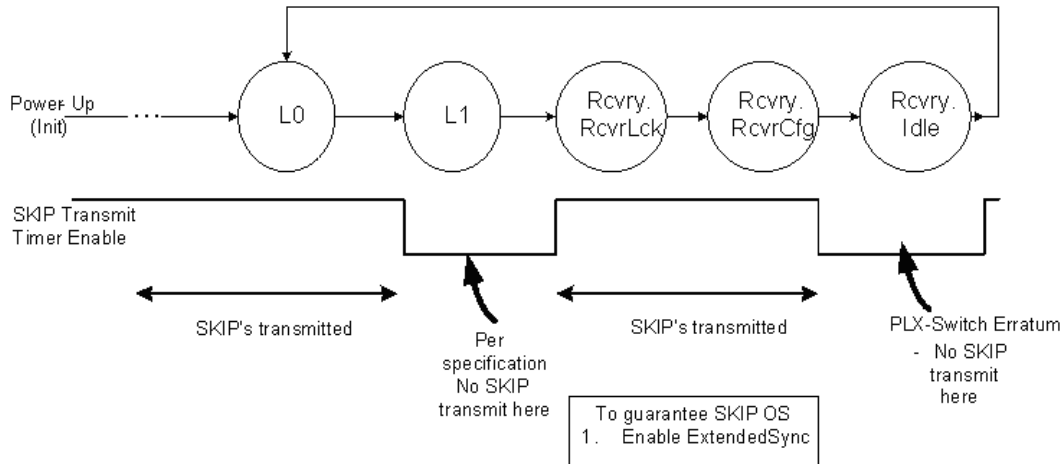
When exiting from the L1 Power Management (PM) state, there is a narrow window (recovery.idle state) during which SKIP ordered sets are not transmitted. The exit from L1 PM state steps through 3 sub-states:

For the duration in which the link is in Recovery.idle state (waiting for receipt of 8 Idle symbols) there will be no SKIP ordered sets transmitted. Note, SKIP symbols will be transmitted properly when entries into recovery sub-states are from another (L0 or L0s) state.

The Figure below illustrates the behavior.

PCI Express devices whose PHY require SKIP ordered sets to deskew and also to exit the recovery path shown above could fail L1 entry/exit and reach the L0 state >100ms later; consequently, taking the link down along the way. The workarounds listed above can be used to prevent the failing case. Note that when using Workaround 1, the PEX 8509 will not realize any L1 power savings.

1. Disable the PEX 8509 upstream port's entry to L1 state for ASPM L1 [78h[1:0]] and PCI PM (device specific offset 1E0[7]) mechanisms.
2. Enable the ExtendedSync mode (Offset 78h[7]), to guarantee SKIP ordered sets in the RcvrLck and RcvrCfg states (shown above)
