Device **TC26x**
Marking/Step **ES-BC, BC**
Package **see Data Sheet**

10212AERRA

This Errata Sheet describes the deviations from the current user documentation.

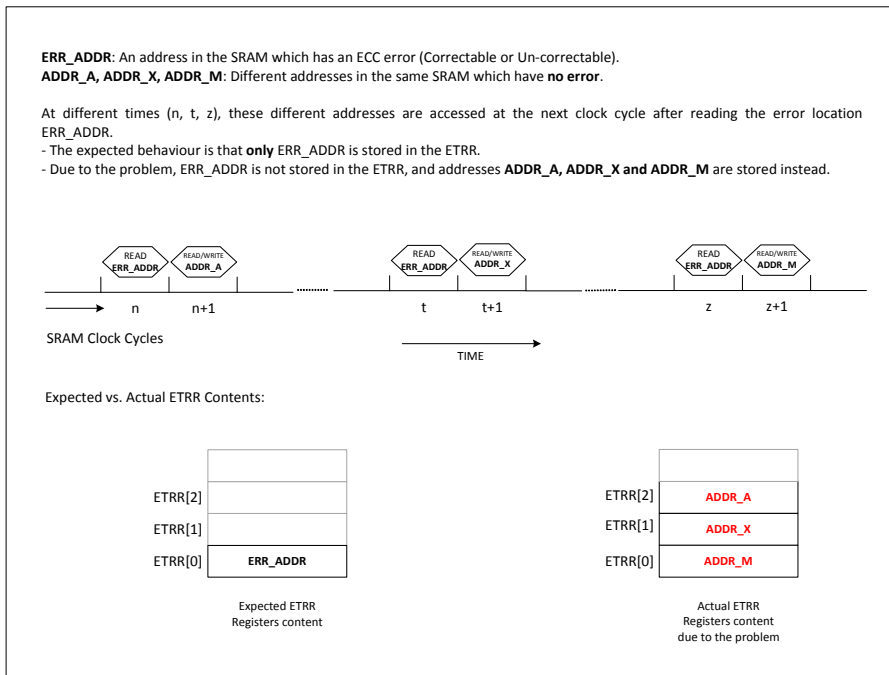
Figure 4 Example sequence showing how registers ETRRx may be filled with “Error Free” addresses

When such a consecutive access sequence (read from ERR_ADDR followed by read/write of different address(es)) happens multiple times, registers ETRRx are filled with addresses that have actually no error – and the SRAM address which actually has an error is not stored indeed. **Figure 4** shows such an example scenario.

The consequence of the scenario explained in **Figure 4** is that a single error in the SRAM – example just one correctable error at a location ERR_ADDR – can result in registers ETRRx getting filled with fault-free address, and thus potentially even triggering an ETRR overflow.

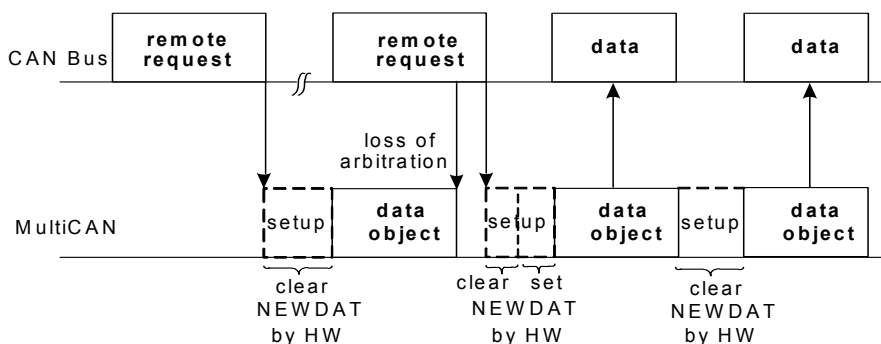
Figure 11 Loss of Arbitration
MultiCAN_TC.H007 Oscillating CAN Bus may Disable the CAN Interface

When the appropriate message object (data frame) triggered by the first remote frame wins the arbitration, it will be sent out and NEWDAT is not reset. This leads to an additional data frame, that will be sent by this message object (clearing NEWDAT).

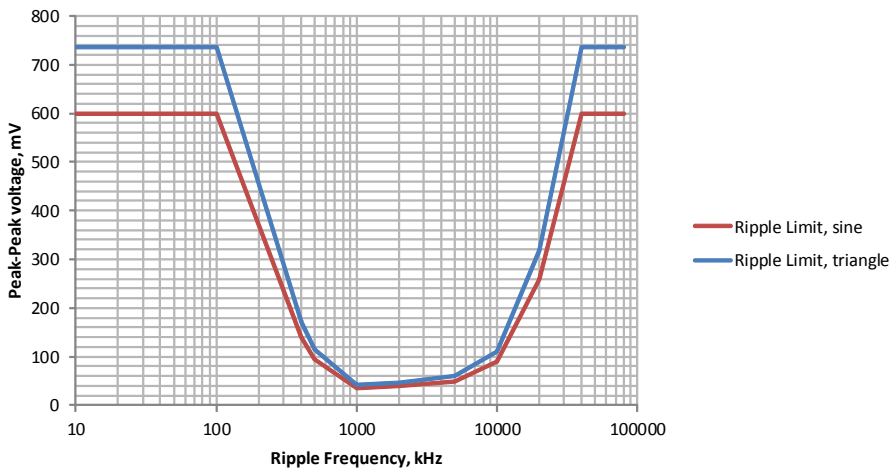
Figure 14 Ripple Voltage vs. Frequency Characteristic

The internal back-up clock is sensitive to specific power supply voltage disturbance/ripple caused by a voltage ripple intrinsic to DC-DC converters. Specific conditions such as insufficient filtering of the ripple may lead to improper behavior of the start-up scheme of the back-up clock, and thus stuck-at state during the start-up of the microcontroller until this condition is removed.

The diagram reflects acceptable ripple level during the cold start of the microcontroller at the respective VDDP3/VEXT/VEVRSB supply of the PMS subsystem, depending on the device and package type, as shown in the following table.

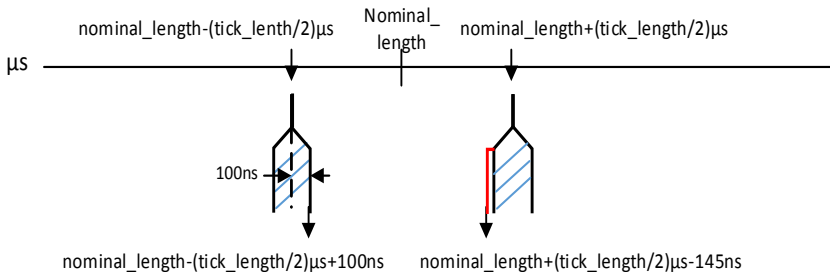
Figure 16 SENSE Tolerance of this Design Step

- The lower border is $\text{nominal_value} - (\text{tick_length}/2) \mu\text{s} + 100 \text{ ns}$
- The upper border is $\text{nominal_value} + (\text{tick_length}/2) \mu\text{s} - 145 \text{ ns}$.
