**ABSTRACT**

This document describes the known exceptions to the functional specifications (advisories).

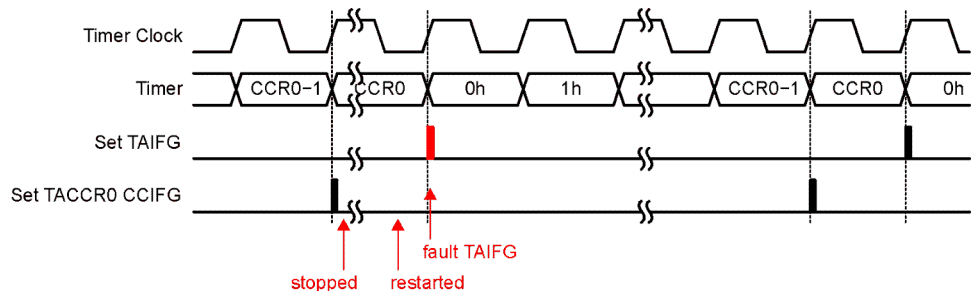
**TA21** *TA Module*

**Function** TAIFG Flag is erroneously set after Timer A restarts in Up Mode

**Description** In Up Mode, the TAIFG flag should only be set when the timer counts from TACCR0 to zero. However, if the Timer A is stopped at TAR = TACCR0, then cleared (TAR=0) by setting the TACLK bit, and finally restarted in Up Mode, the next rising edge of the TACLK will erroneously set the TAIFG flag.

**Workaround** None.

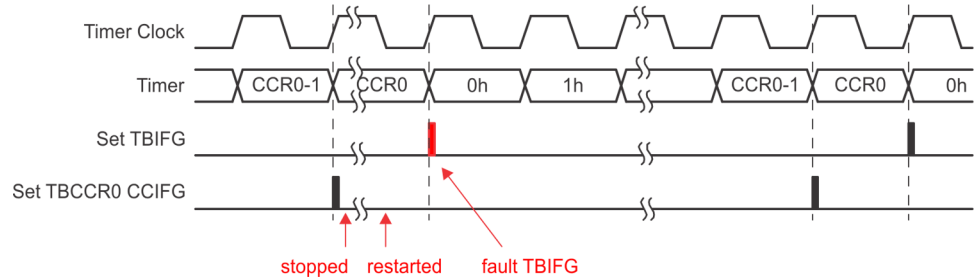
<b>Workaround</b>	None
<b>TB24</b>	<b>TB Module</b>
<b>Category</b>	Functional

**Function** TBIFG Flag is erroneously set after Timer B restarts in Up Mode

**Description** In Up Mode, the TBIFG flag should only be set when the timer resets from TBCCR0 to zero. However, if the Timer B is stopped at TBR = TBCCR0, then cleared (TBR=0) by setting the TBCLR bit, and finally restarted in Up Mode, the next rising edge of the TBCLK will erroneously set the TBIFG flag.

**Workaround** None.
