## STM32G471xx/473xx/474xx/483xx/484xx device errata

This document applies to the part numbers of STM32G471xx/473xx/474xx/483xx/484xx devices and the device variants as stated in this page.

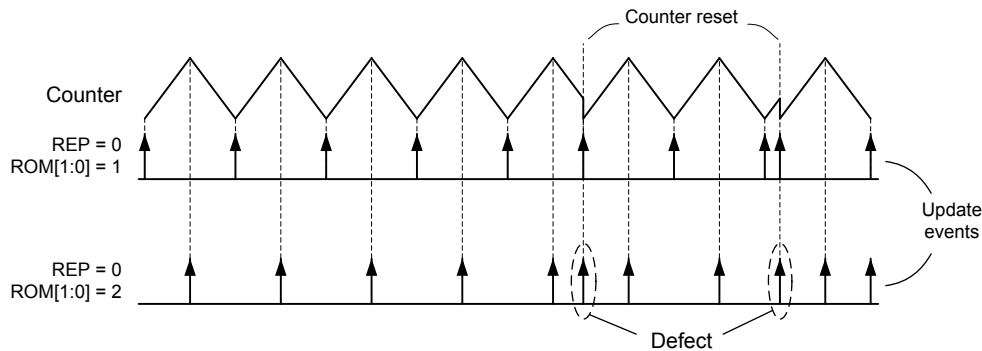
In up-down counting mode, the value 2 in the roll-over mode bitfield ROM[1:0] sets the corresponding roll-over event to occur when the counter rolls over the crest, which then induces timer register update, based on other settings. However, with ROM[1:0] at 2, the register update is also unduly triggered upon the counter reset, as illustrated:

The defect impacts the timer x operation with the following settings:

- TxREPU = 1, for the update when the timer x repetition counter reaches zero (in this case, the spurious roll-over event at the counter reset propagates to register update event while not decrementing the repetition counter)
- TxRSTU = 1, for the update upon timer x reset
- RSYNCU = 1, for the update re-synchronized with the counter roll-over event

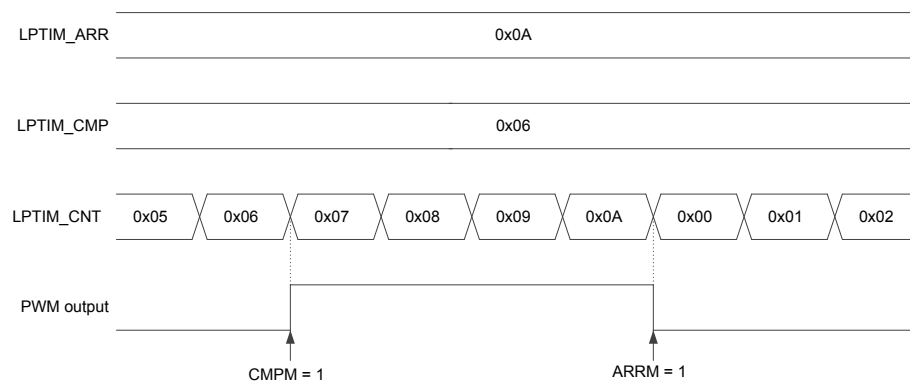
Consequently, it is not possible to generate PWM with a duty cycle of 0% or 100%.

The following waveform gives the example of PWM output mode and the effect of the delay:

Set the compare value to the desired value minus 1. For instance in order to generate a compare match when LPTM\_CNT = 0x08, set the compare value to 0x07.
