AVR128DA28/32/48/64

Silicon Errata and Data Sheet Clarification

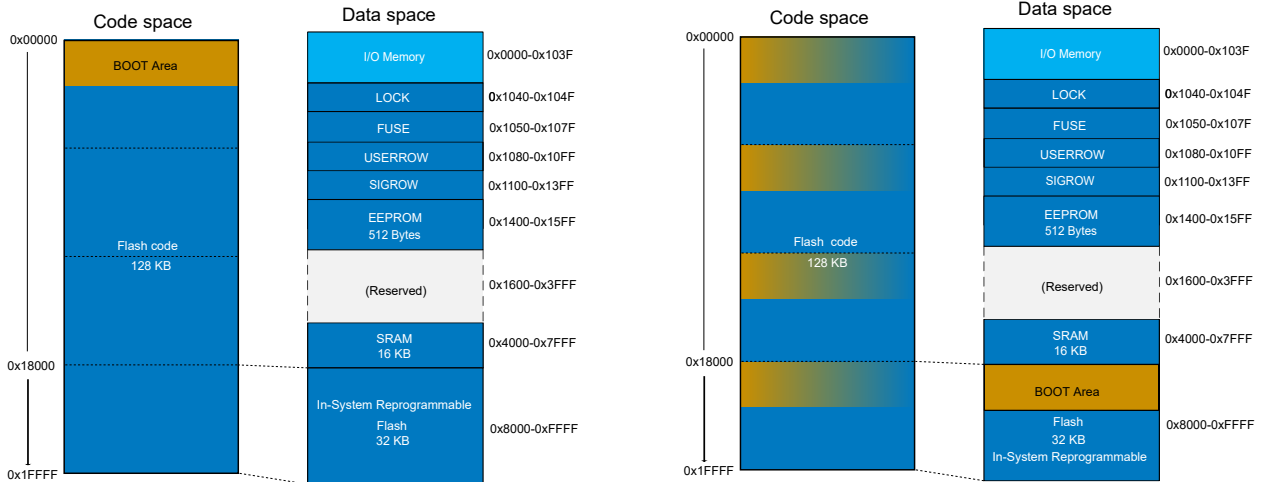
2.4.1 Flash Mapping into Data Space Not Working Properly

The inter-section Flash protection mechanism does not take into account the FLMAP bit field in the NVMCTRL.CTRLB register when checking if the address is in BOOT, APPCODE or APPDATA sections. It uses for comparison only the address offset between Flash start address in data space (0x8000) and the accessed address. This will cause the mirroring of the BOOT section in each Flash section selected by FLMAP (in blocks of 32 KB). See image below:

BOOT area for devices without issue

BOOT area for devices with issue

For read operations, the FLMAP bit field works as documented when the Boot Read Protect (BOOTRP) bit is not enabled.

For write operations, the inter-section Flash protection works properly only when FLMAP is set to 0x00.

Use only store program memory (SPM) instructions to write and load program memory (LPM) instructions to read Flash memory.
