dsPIC33CH512MP508 Family Silicon Errata and Data Sheet Clarification

The dsPIC33CH512MP508 family devices that you have received conform functionally to the current Device Data Sheet (DS70005371D), except for the anomalies described in this document.

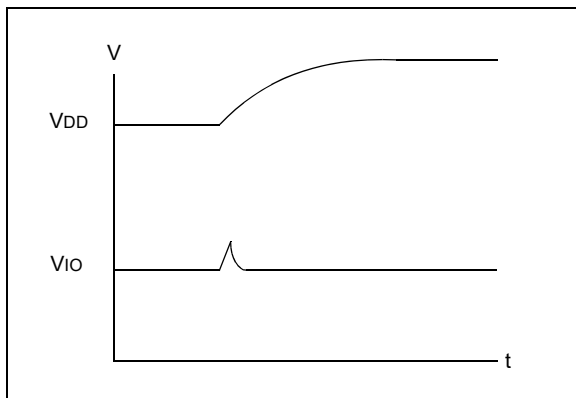
FIGURE 1-1: I/O RAMP

During a fast device power-up, when the VDD ramp is less than 4 mS, the I/O pins may drive up to 100 μ A current for a duration of up to 10 μ S (Figure 1-1).

Example applications affected may include complementary power switches, where a transient current shoot-through might occur. High-voltage applications with complementary switches should power the high-voltage 200 μ Sec later than powering the dsPIC[®] device to avoid the current shoot-through. This behavior is specific to each device and not affected by aging.

1. Slow down the VDD ramp time (greater than 4 mS for VDD to ramp 0V to 3.3V).
2. Ensure the circuitry that is connected to the pins can endure this pulse.

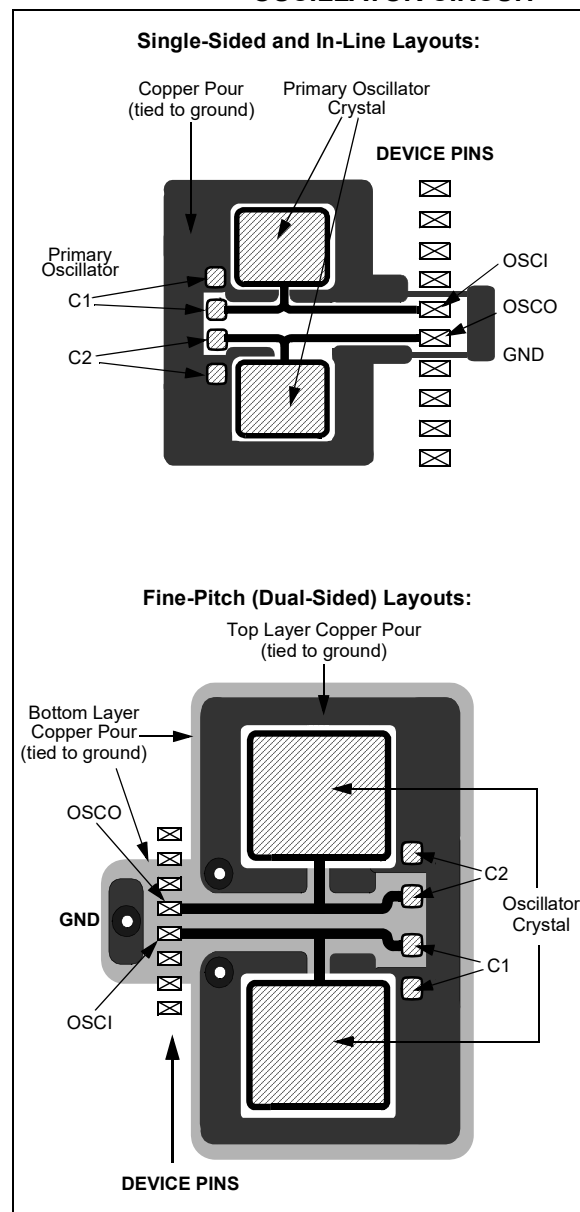
FIGURE 2-2: SUGGESTED PLACEMENT OF THE OSCILLATOR CIRCUIT

When the Primary Oscillator (POSC) circuit is used to connect a crystal oscillator, special care and consideration is needed to ensure proper operation. The POSC circuit should be tested across the environmental conditions that the end product is intended to be used. The load capacitors specified in the crystal oscillator data sheet can be used as a starting point, however, the parasitic capacitance from the PCB traces can affect the circuit and the values may need to be altered to ensure proper start-up and operation.

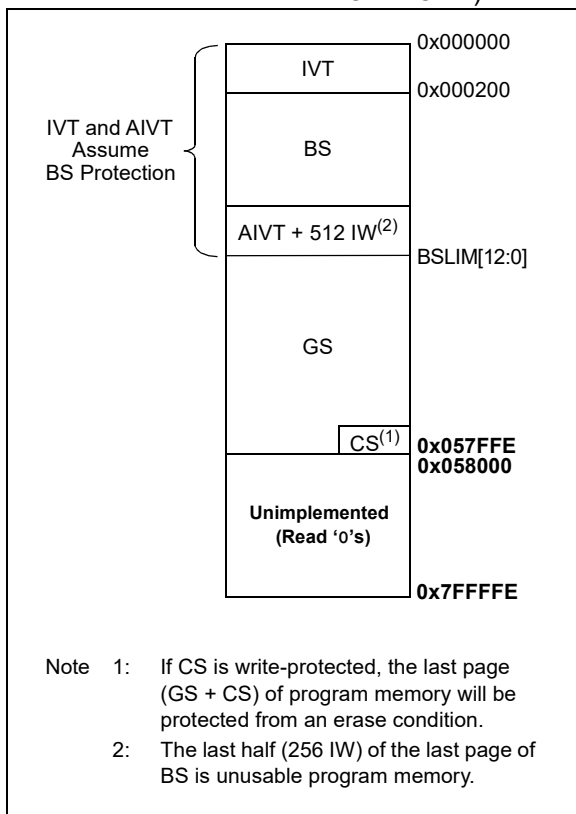
FIGURE 21-4: FLASH SECURITY SEGMENTS (SINGLE PARTITION MODE)

Figure 21-4 has been updated as shown in **bold** below.

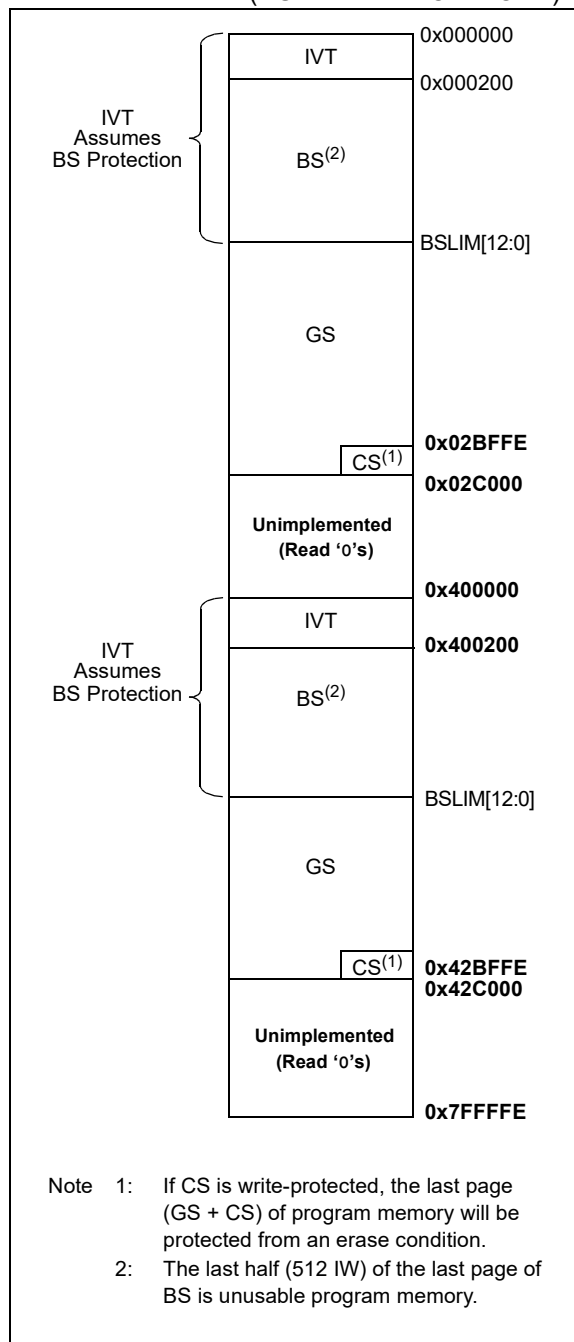
FIGURE 21-5: FLASH SECURITY SEGMENTS (DUAL PARTITION MODE)

Figure 21-5 has been updated as shown in **bold** below.

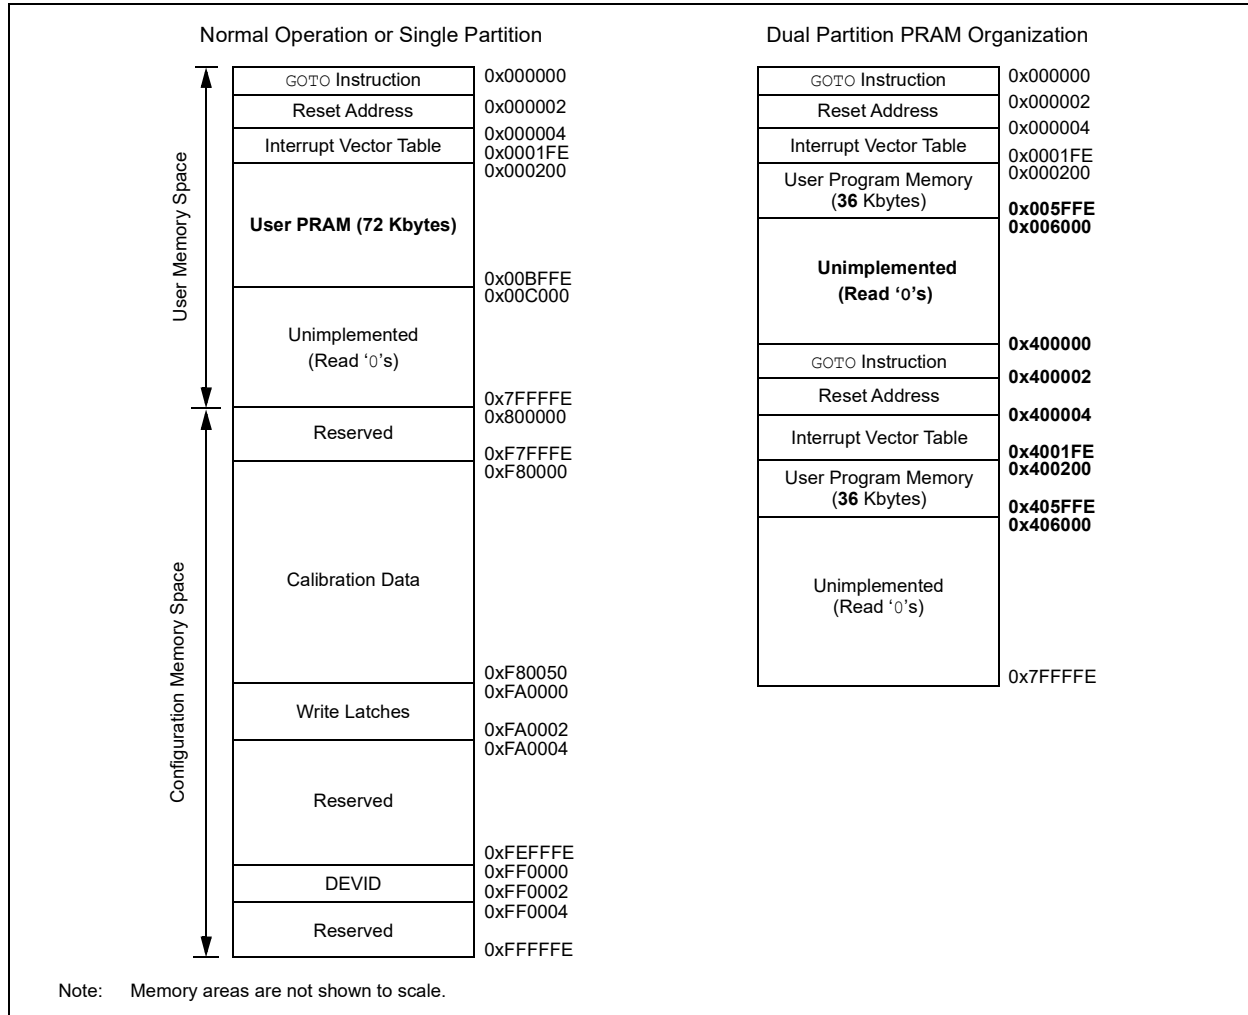
FIGURE 4-3: PRAM (PROGRAM MEMORY) FOR SECONDARY CORE dsPIC33CH512MP508S1 DEVICES

Figure 4-3 has been updated as shown in **bold** below.
