Device TC27x
Marking/Step ES-DC, DC
Package see Data Sheet

10318AERRA

This Errata Sheet describes the deviations from the current user documentation.

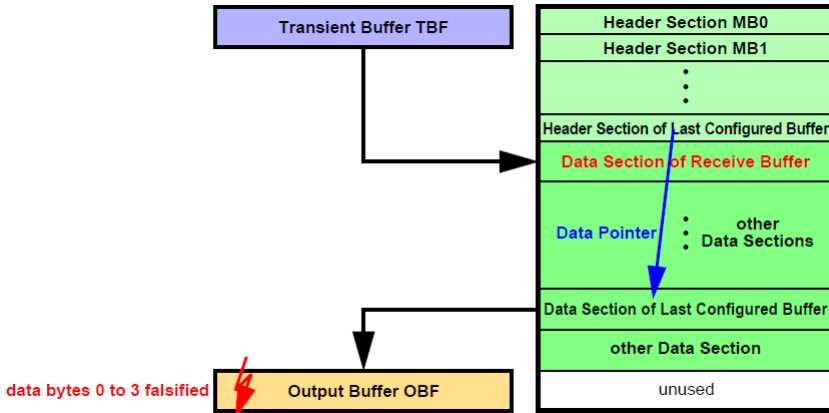
Figure 1 Message buffer transfer from Message RAM to OBF

When the message buffer has its payload configured to maximum length (PLC = 127), the OBF word on address 00h (payload data bytes 0 to 3) is overwritten with unexpected data at the end of the transfer.

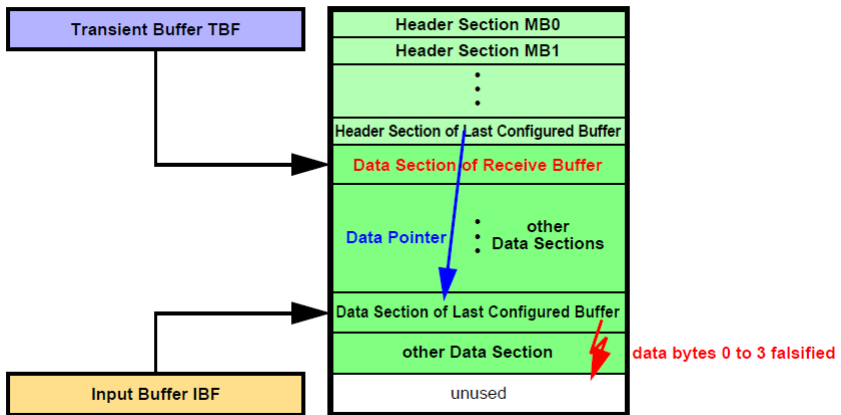
Figure 2 Message buffer transfer from IBF to Message RAM

After the Data Section of the selected message buffer in the Message RAM has been written, one additional write access overwrites the following word in the Message RAM which might be the first word of the next Data Section.

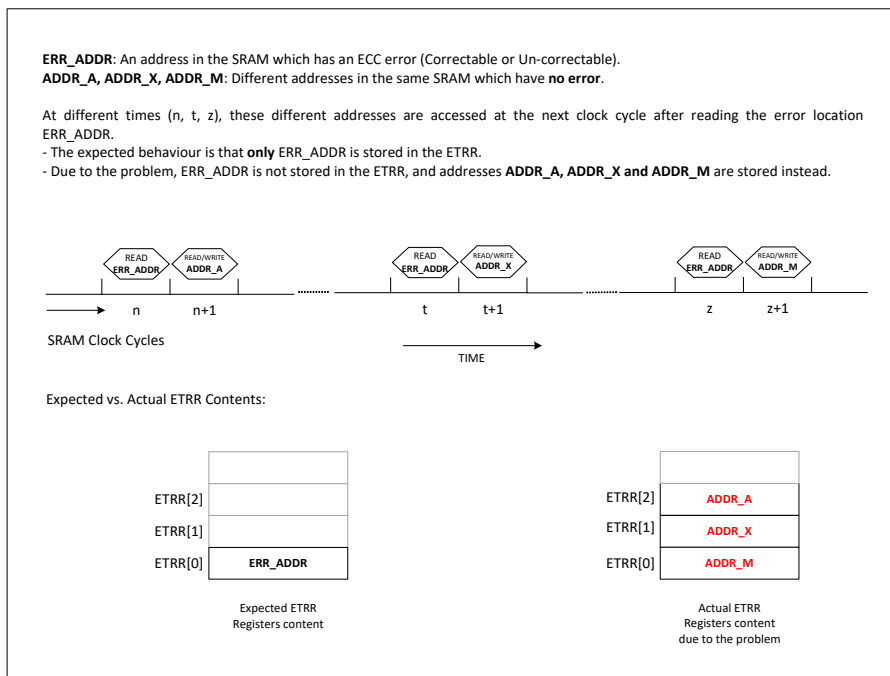
Figure 4 Example sequence showing how registers ETRRx may be filled with “Error Free” addresses

When such a consecutive access sequence (read from ERR_ADDR followed by read/write of different address(es)) happens multiple times, registers ETRRx are filled with addresses that have actually no error – and the SRAM address which actually has an error is not stored indeed. **Figure 4** shows such an example scenario.

The consequence of the scenario explained in **Figure 4** is that a single error in the SRAM – example just one correctable error at a location ERR_ADDR – can result in registers ETRRx getting filled with fault-free address, and thus potentially even triggering an ETRR overflow.

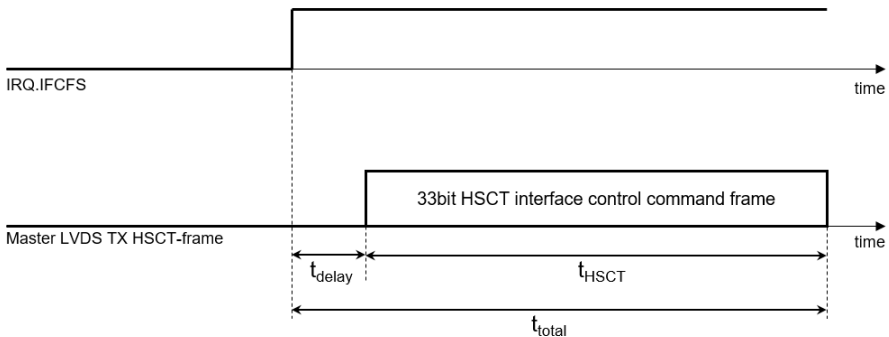
Figure 9 Timing of LVDS TX interface command sending in relation to IRQ.IFCFS

the user might falsely assume that also the actual sending on the LVDS TX port has already occurred once the IRQ.IFCFS flag is set, which is not true.

Instead the timing shown in **Figure 9** applies.

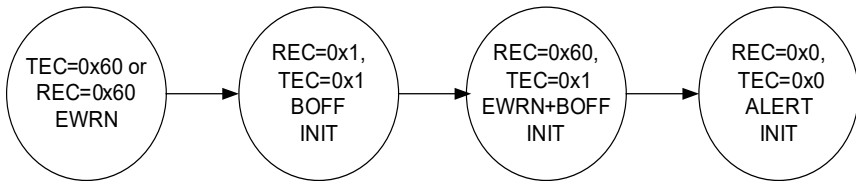
Figure 11 Alert Interrupt Behavior in case of Bus-Off

The MultiCAN module shows the following behavior in case of a bus-off status:

When the threshold for error warning (EWRN) is reached (default value of Error Warning Level EWRN = 0x60), then the EWRN interrupt is issued. The bus-off (BOFF) status is reached if $TEC > 255$ according to CAN specification, changing the MultiCAN module with REC and TEC to the same value 0x1, setting the INIT bit to 1_B, and issuing the BOFF interrupt. The bus-off recovery phase starts automatically. Every time an idle time is seen, REC is incremented. If REC = 0x60, a combined status EWRN+BOFF is reached. The corresponding interrupt can also be seen as a pre-warning interrupt, that the bus-off recovery phase will be finished soon. When the bus-off recovery phase has finished (128 times idle time have been seen on the bus), EWRN and BOFF are cleared, the ALERT interrupt bit is set and the INIT bit is still set.

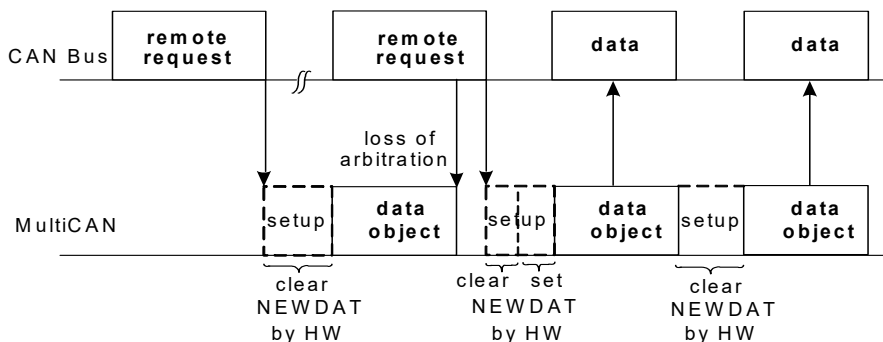
Figure 12 Loss of Arbitration

When the appropriate message object (data frame) triggered by the first remote frame wins the arbitration, it will be sent out and NEWDAT is not reset. This leads to an additional data frame, that will be sent by this message object (clearing NEWDAT).

There will, however, not be more data frames than there are corresponding remote requests.

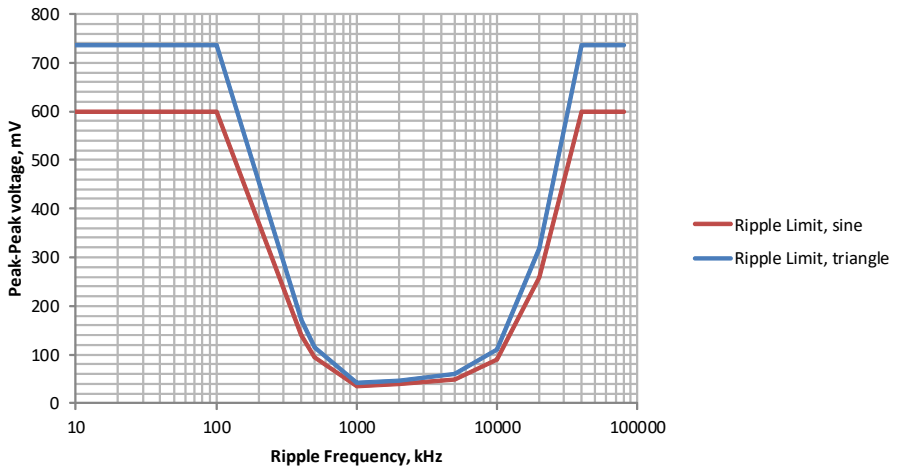
Figure 16 Ripple Voltage vs. Frequency Characteristic

The internal back-up clock is sensitive to specific power supply voltage disturbance/ripple caused by a voltage ripple intrinsic to DC-DC converters. Specific conditions such as insufficient filtering of the ripple may lead to improper behavior of the start-up scheme of the back-up clock, and thus stuck-at state during the start-up of the microcontroller until this condition is removed.

The diagram reflects acceptable ripple level during the cold start of the microcontroller at the respective VDDP3/VEXT/VEVRSB supply of the PMS subsystem, depending on the device and package type, as shown in the following table.

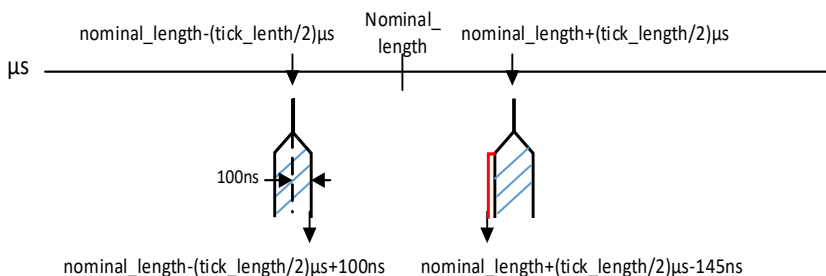
Figure 18 SENT Tolerance of this Design Step

In this design step the range is delimited as follows:

- The lower border is $\text{nominal_value} - (\text{tick_length}/2) \mu\text{s} + 100 \text{ ns}$
- The upper border is $\text{nominal_value} + (\text{tick_length}/2) \mu\text{s} - 145 \text{ ns}$.

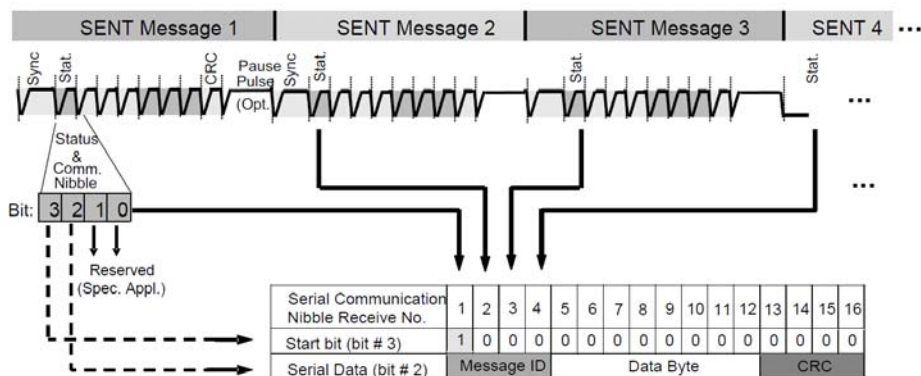
Figure 19 Short Serial Message, Serial Data Encoding over 16 messages

Figure 19 shows a corrected version of this figure.

One serial message is composed of 16 SENT consecutive error-free messages.
