STM32F100xC, STM32F100xD and STM32F100xE high-density value line device errata

This document applies to the part numbers of STM32F100xC, STM32F100xD and STM32F100xE high-density value line devices and the device variants as stated in this page.

It gives a summary and a description of the device errata, with respect to the device datasheet and reference manual RM00041.

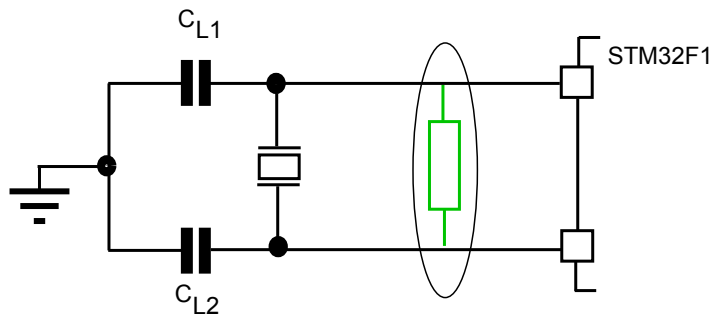
Figure 1. LSE startup using an additional resistor

The LSE (low-speed external) oscillator system has been designed to minimize the overall power consumption of the microcontroller. It is extremely important to take specific care in the design of the PCB to ensure this low power oscillator starts in harsh conditions. In some PCB designs without coating, an induced low leakage may prevent the LSE to startup, regardless of the 32.768 KHz crystal used. This phenomenon is amplified in humid environments that create frost on the OSC32_IN/OSC32_OUT tracks. This unwanted behavior may happen only at the first back-up domain power-on of the device.

It is recommended to mount an additional parallel feedback resistor (from 16 M Ω to 22 M Ω) on board to help the oscillation startup in all cases (see [Figure 1](#)). For more details on compatible crystals and hardware techniques on PCB, refer to application note *Oscillator design guide for STM8AF/AL/S, STM32 MCUs and MPUs* (AN2867).
