# TLE985x-Errata-100-Infineon

## TLE985xQX(W) Family

This document lists the errata of the TLE985xQX(W) family.

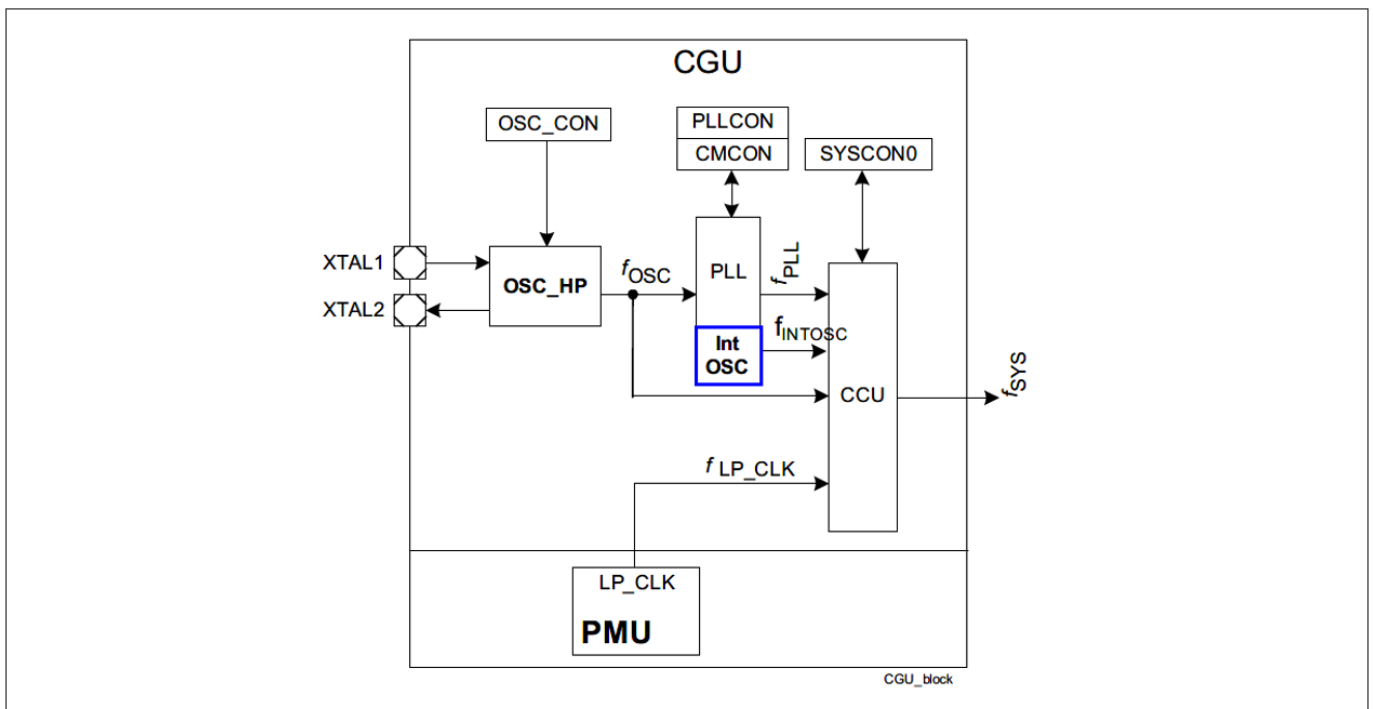
Figure 1 Clock generation unit block diagram

The TLE985x provides a Phase-Locked-Loop (PLL) to generate the system frequency. Under certain conditions it may happen that the PLL issues a loss of lock. The probability for an erroneous PLL loss of lock to occur increases with higher temperature and longer operation times.

In case of a PLL loss of lock, the system frequency will be switched to free running clock divided by K2, this might have the following effects to the application:

- System timing do not match anymore, e.g. LIN communication might not work properly, PWM period might be affected.
- WDT1 reset may occur.
- Digital filter times might not match anymore.

As the source of the loss of lock detection is within the lock detection unit, a possible workaround is to bypass the PLL and use the internal oscillator (marked blue in [Figure 1](#)) as system frequency source only. This will lead to a fixed system frequency of 40 MHz.

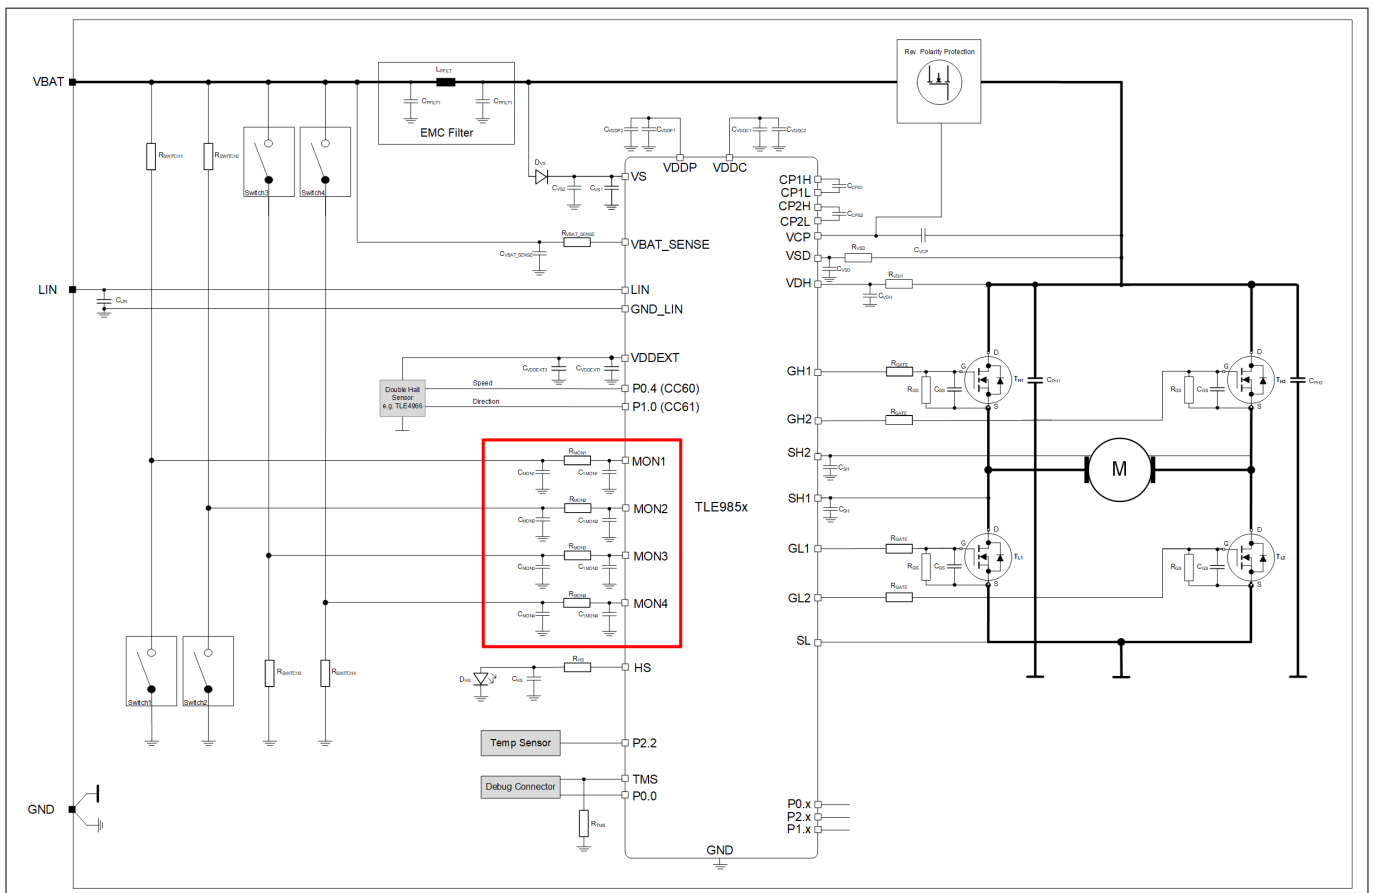
Figure 3 Application diagram example with C-R-C filters at MONx

Fast transients on an enabled ADC1 HV-Channel could activate the ADC sampling switch, which will lead to a load of 10 kΩ (+/- 20%) on the causing channel.

The activation will increase the input current (> 100 μA @  $V_S$  13.5 V) on the corresponding MONx pin. This increased current can cause a voltage drop across the external resistor. Depending on the value of the resistor, the voltage drop can be so high that a wrong low signal on the MONx will be detected.

To achieve robustness against ISO 7637-3 pulses, the recommended R-C filter from the Data Sheet is sufficient. To increase the robustness, an additional 10 nF capacitor ( $C_{1MONx}$ ) is recommended. This will lead to a C-R-C filter. See [Figure 3](#).
