## Product Advisory

Issue Date: September 15, 2022

Whitney+ power reduction configuration support in 2.25

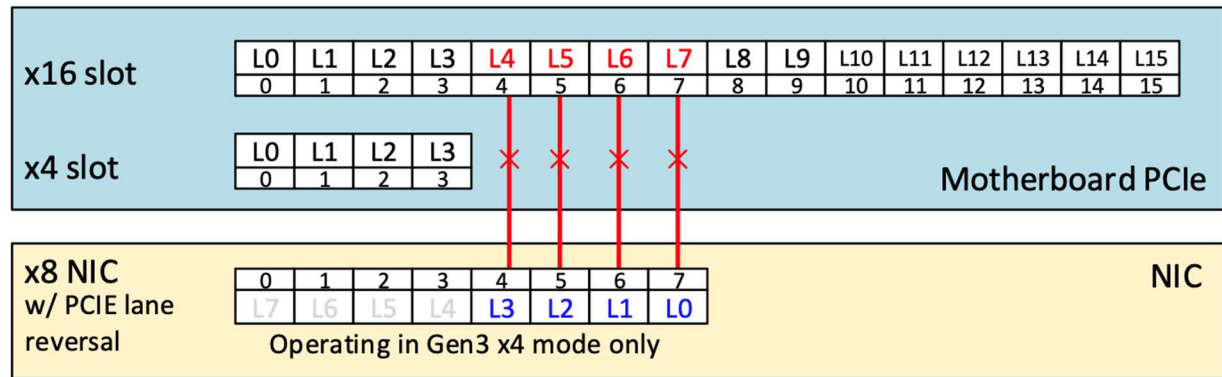
### Example of **Incompatible** Motherboard Configuration

Above listed Broadcom NICs implement PCIe lane reversal (table 1) on the PCB, which may be incompatible with certain motherboards after enabling the power reduction feature. If the feature is enabled on an incompatible motherboard, **the card will not be detected by the host over the PCIe bus.**

The above sequence of events will result in the card not getting detected on incompatible motherboards. To recover the card, the customer will need to move the NIC card to a compatible system, disable the feature, and then move the card back to the original motherboard.

- Users must consult the FAE Advisory “Wh+ 10G Power Reduction Feature in 2.25 FW Release” to ensure system compatibility before enabling this feature.
- Customers should test the power reduction feature first before mass deploying the feature in the field for the NIC cards listed above.
- Follow the Firmware upgrade & downgrade considerations provided in the reference document.
