## STM32F76xxx/77xxx device errata

## Applicability

This document applies to the part numbers of STM32F76xxx/77xxx devices and the device variants as stated in this page. It gives a summary and a description of the device errata, with respect to the device datasheet and reference manual RM0341. Deviation of the real device behavior from the intended device behavior is considered to be a device limitation. Deviation of the description in the reference manual or the datasheet from the intended device behavior is considered to be a documentation erratum. The term “errata” applies both to limitations and documentation errata.

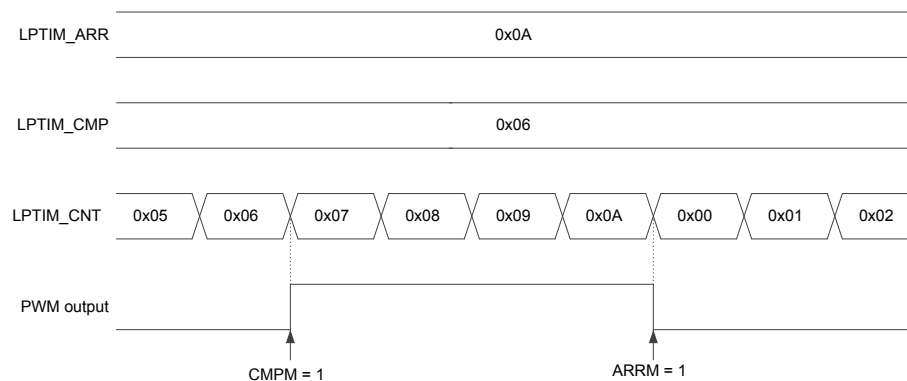
Consequently, it is not possible to generate PWM with a duty cycle of 0% or 100%.

The following waveform gives the example of PWM output mode and the effect of the delay:

Set the compare value to the desired value minus 1. For instance in order to generate a compare match when LPTM\_CNT = 0x08, set the compare value to 0x07.

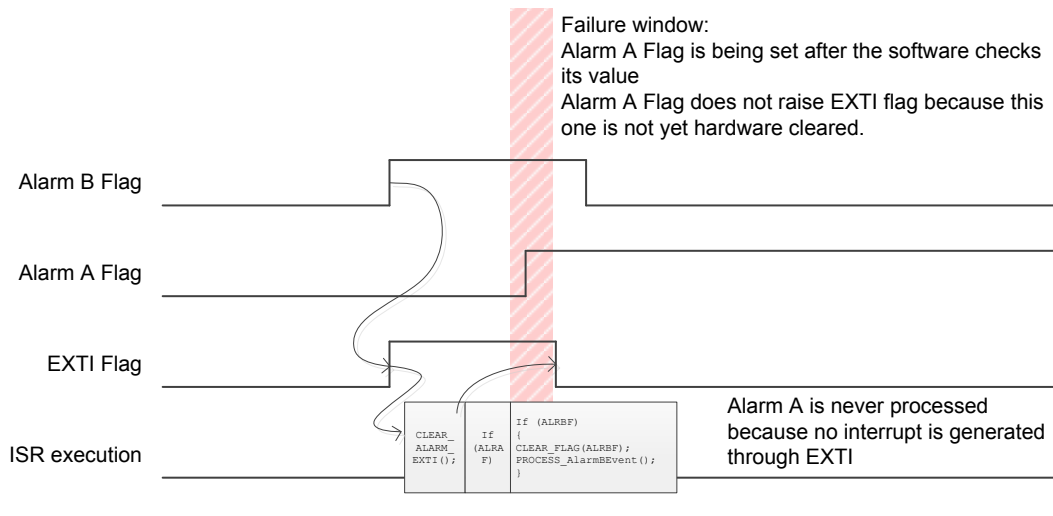
Figure 1. Masked RTC interrupt

The following code example and figure illustrate the failure mechanism: The Alarm A event is lost (fails to generate interrupt) as it occurs in the failure window, that is, after checking the Alarm A event flag but before the effective clear of the EXTI interrupt flag by hardware. The effective clear of the EXTI interrupt flag is delayed with respect to the software instruction to clear it.

In the interrupt service routine, apply three consecutive event flag checks - source one, source two, and source one again, as in the following code example:
