dsPIC33CH512MP508 Family Silicon Errata and Data Sheet Clarification

The dsPIC33CH512MP508 family devices that you have received conform functionally to the current Device Data Sheet (DS70005371D), except for the anomalies described in this document.

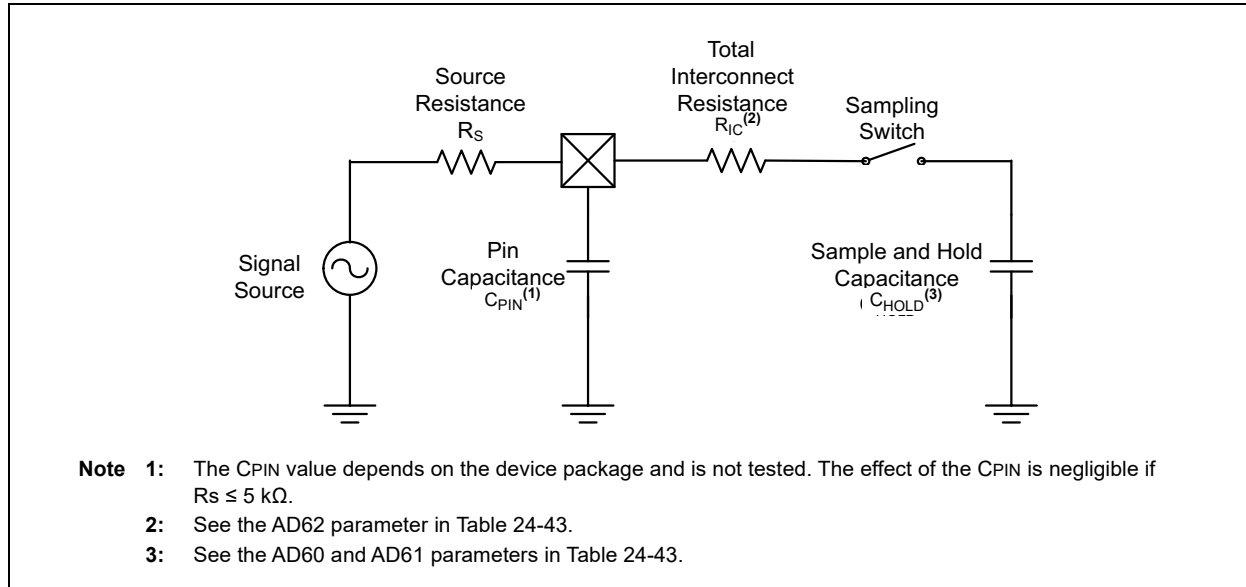
FIGURE: ADC ANALOG INPUT MODEL

The analog input model of the ADC is shown in the figure below.

The total acquisition time for the Analog-to-Digital conversion is a function of the Holding Capacitor (C_{HOLD}) charge time. For the ADC module to meet its specified accuracy, the Holding Capacitor (C_{HOLD}) must be allowed to fully charge to the voltage level on the analog input pin. The Signal Source Impedance (R_S) and the Interconnect Impedance (R_{IC}) combine to affect the time required to charge the C_{HOLD} . The total resistance ($R_S + R_{IC}$) must therefore, be small enough to fully charge the Holding Capacitor within the selected sample time.
