Device TC27x
Marking/Step ES-DC, DC
Package see Data Sheet

10318AERRA

This Errata Sheet describes the deviations from the current user documentation.

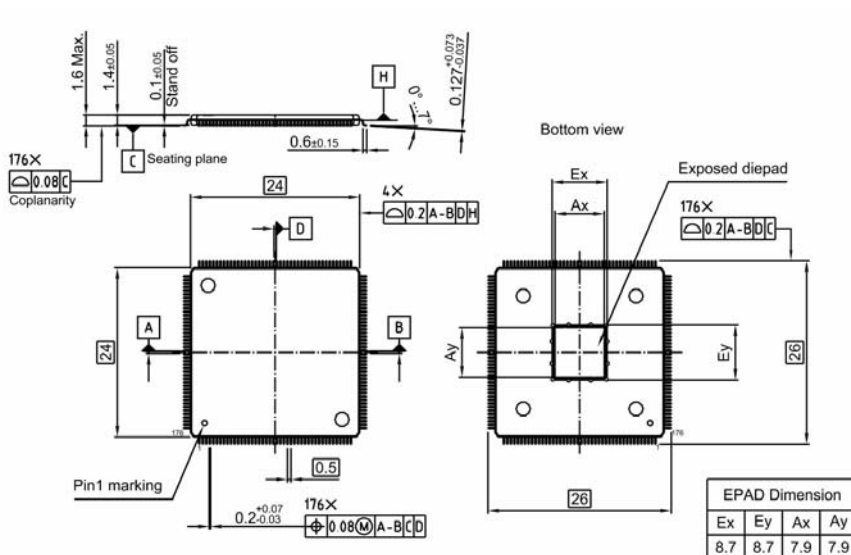
Figure 15 Package Outlines LQFP-176 for TC27x

Note: For the exposed pad of the LQFP-176 package of the TC27x, structural corner protrusions have to be considered for purposes of system design and integration with a maximum boundary of 9.4 mm.

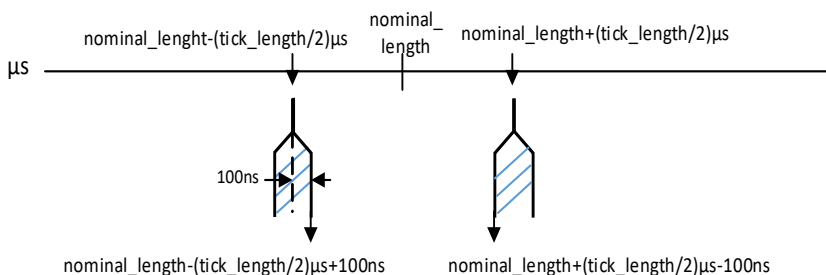
Figure 17 SENT Standard Tolerance

The length of a nibble in the SENT protocol determines the value of this nibble. For each value this length can vary, but it has to be at least inside a given range. This range is given by the SENT standard.

- The lower border is $\text{nominal_value} - (\text{tick_length}/2) \mu\text{s} + 100 \text{ ns}$
- The upper border is $\text{nominal_value} + (\text{tick_length}/2) \mu\text{s} - 100 \text{ ns}$.

In this design step the range is delimited as follows:
