1 Products affected

2 Type of change

Product improvement: Added fixing pins to the socket of the fuseholder.

FPG7					0118.2175	
creation date	created by	release date	released by	notification no.	revision	page
2013-06-05	arnetja	2014-01-15	arnetja	25648	b	1 of 3

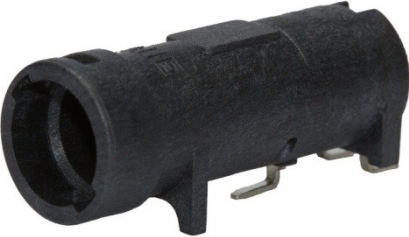
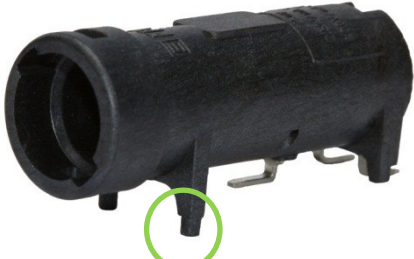
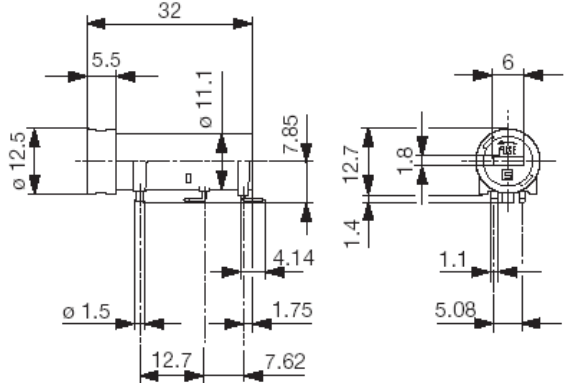
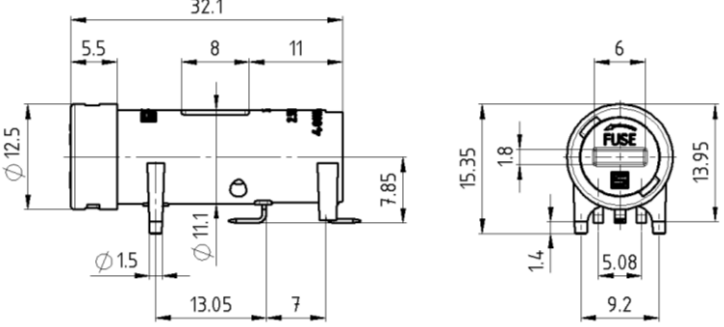
Old socket	New socket

Fixing pins were added to the socket of the FPG7 fuseholder:

Added fixing pins to the socket of the fuseholder for stabilisation during the reflow process and for minimization of the axial force on the solder pads while exchanging the fuse.

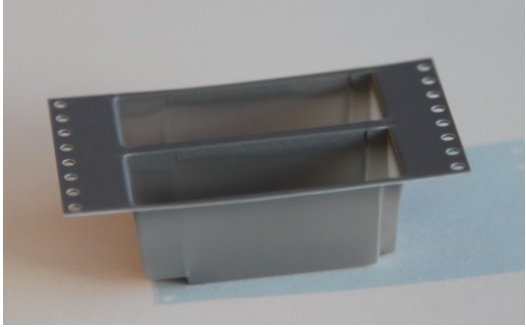
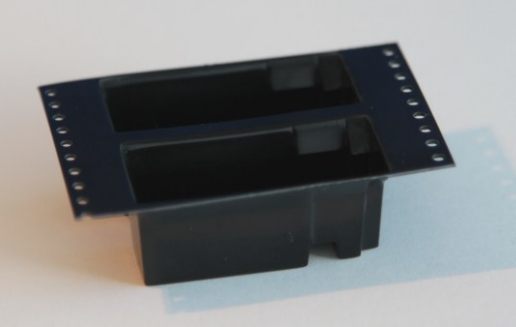
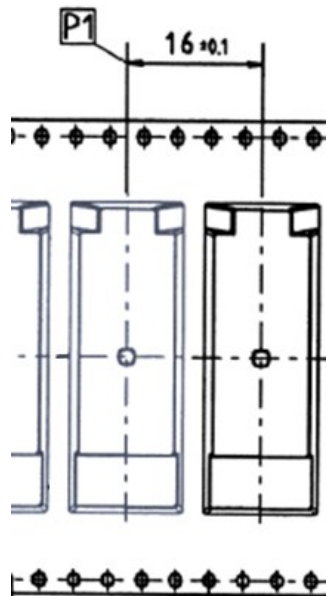
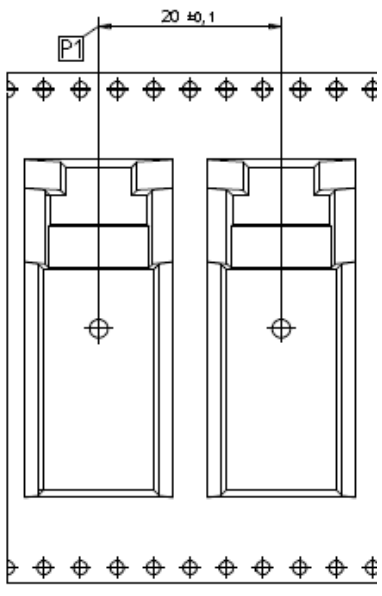
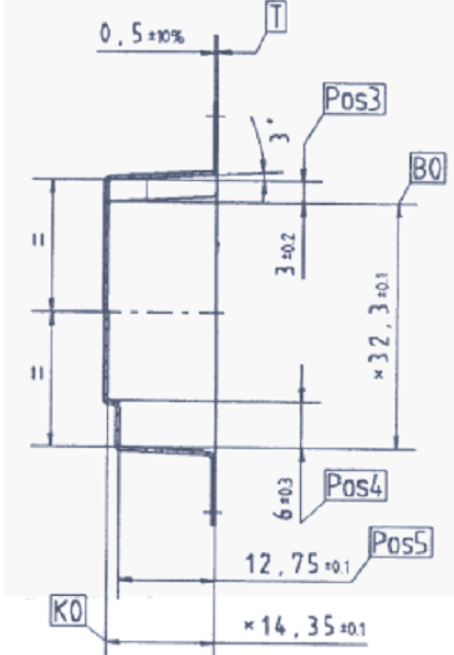
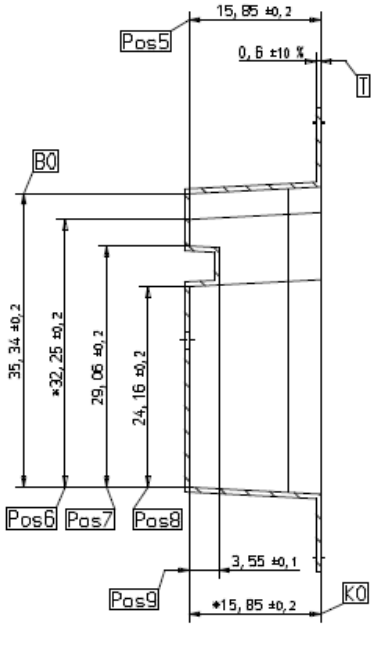
Old blister	New blister

Change of packaging:

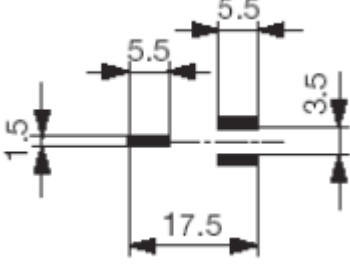
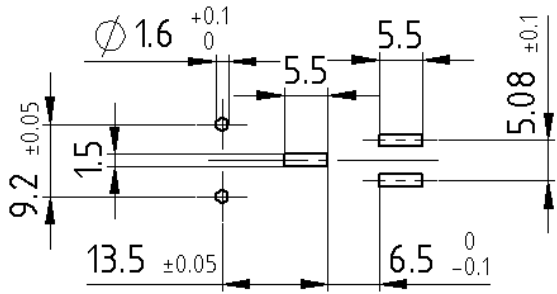
Old PCB layout	New PCB layout

Change of PCB Layout:
